Catastrophic Mains Burst, Liverpool

Repair & Maintenance

Project: Burst Water Mains Pipe

Specification: Large Diameter Stepped Couplings (DN1000)

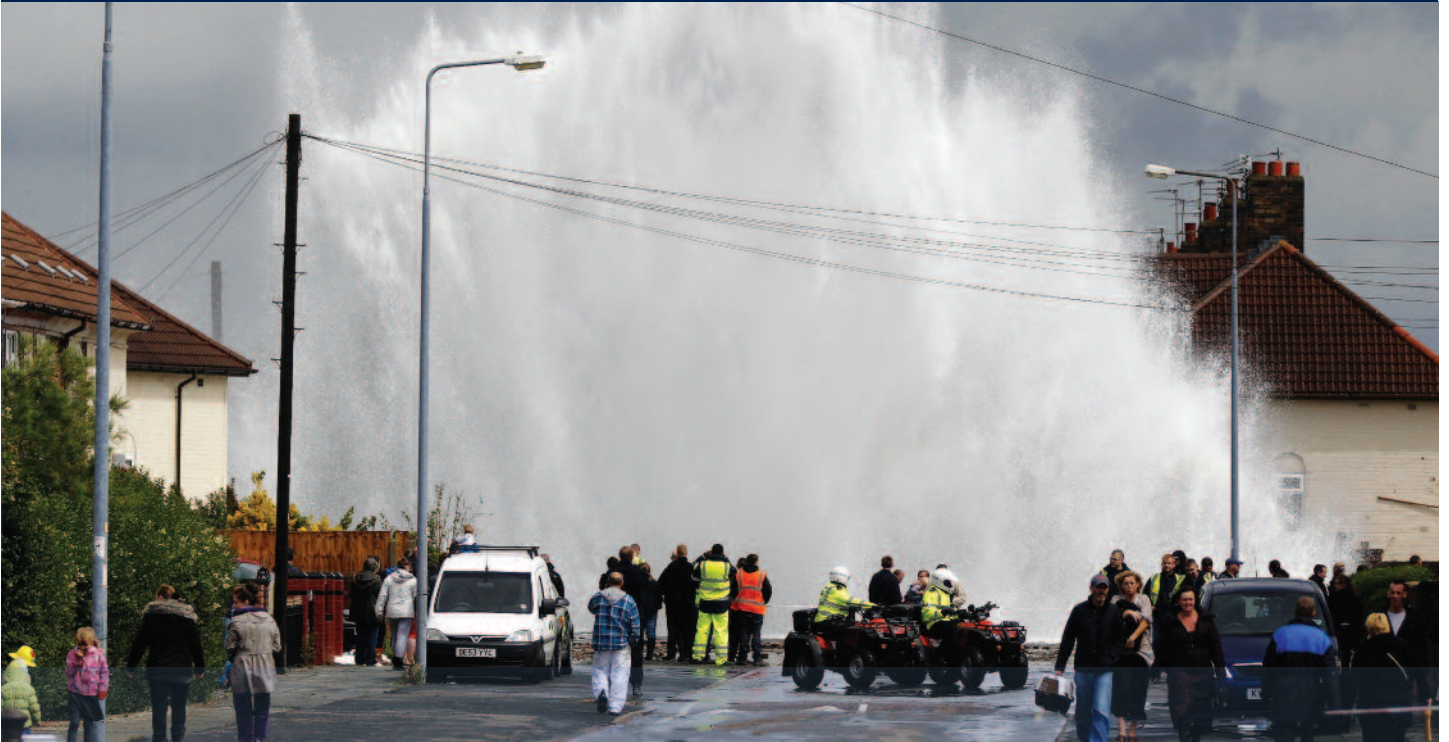
During the summer of 2011, an area of Liverpool experienced catastrophic flooding when a water mains pipe burst, sending huge plumes of water up into the air. Viking Johnson's 24 hour Fast track service ensured that Large Diameter and Stepped couplings were supplied quickly for a fast repair.

As the fire service and water utility tried to control the floods, hundreds of homes and businesses were affected and schools were closed. The burst mains pipe, which had a diameter of forty inches, had to be isolated and the water supply was re-routed through other networks in the area.

In order to fully repair the damage, a new section of pipe was urgently installed into the existing system. United Utilities ordered two bespoke Large Diameter Stepped Couplings (DN1000) which were used to connect the new pipework. They took advantage of Viking Johnson's 24 hour fast track service which enabled a fast delivery and the repair to be carried out as quickly as possible.
