Couplings Fix Flood in Budapest

Water Utilities / Couplings for Water Mains

Project: Repair of water mains in Orly Utca, Budapest, following major leakage

Specification: DN1000 Large Diameter Couplings

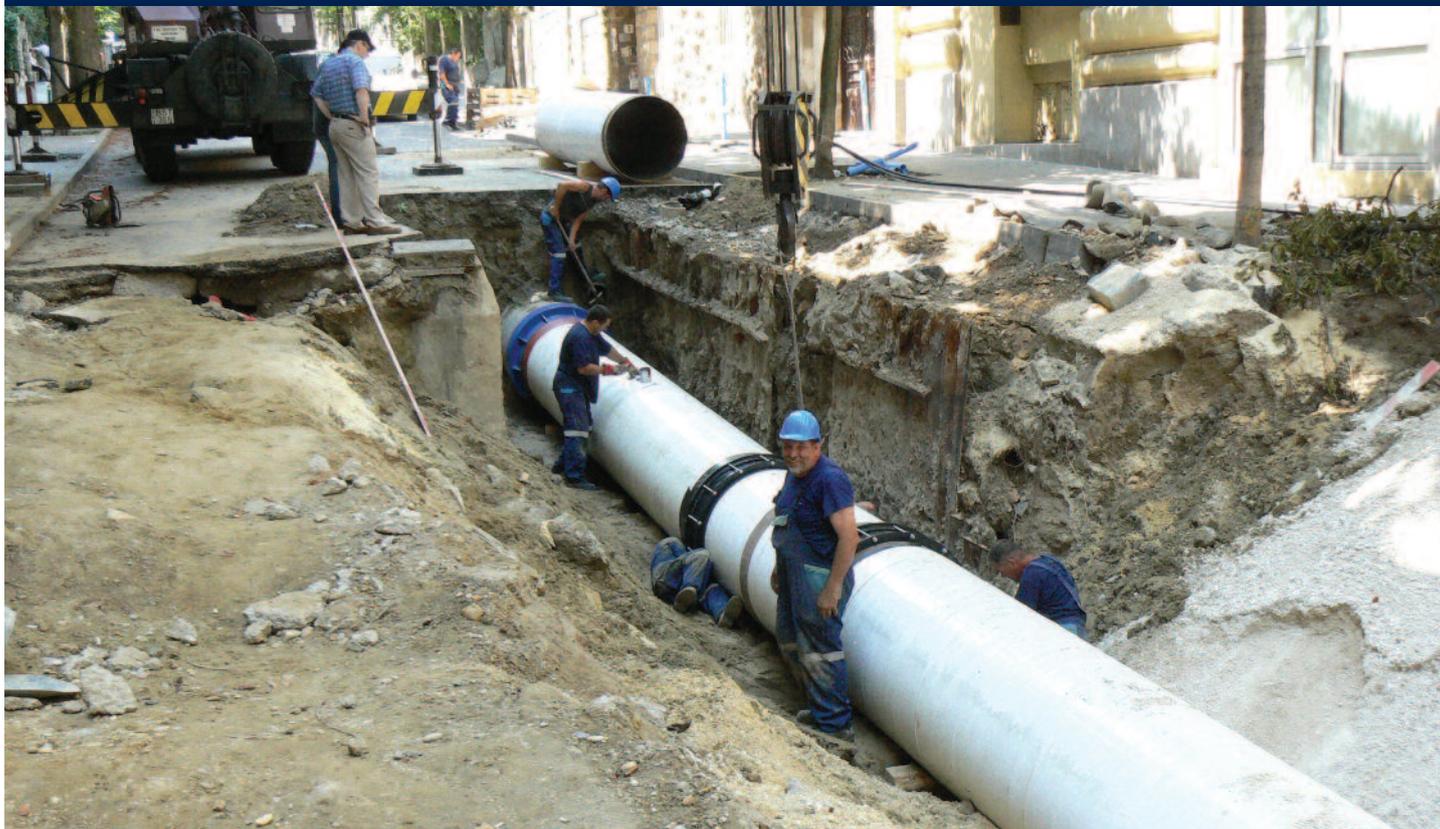
Last summer, Orly utca in Budapest experienced extreme flooding when two potable water mains burst under high pressure. The flooding was so extensive that the water mains were turned off, leaving residents and businesses without drinking water.

The damage began on Sunday July 1st 2012, when two mains pipes, originally fitted in 1976, cracked and burst. Within an hour, Budapest Szent Gellr square was completely flooded, with water reaching the 2nd floor of some buildings. Traffic came to a standstill with passengers even asked to evacuate buses and the BKV tram.

Viking Johnson worked in partnership with Kristály Ltd. to supply Fővárosi Vízművek (Capital Waterworks) with two DN1000 large diameter couplings, helping to repair the broken pipe in less than 24 hours and restoring services to the area.
