East Borneo - Samarinda

Leaking Pipework - Water Treatment Works

Next Generation UltraGrip

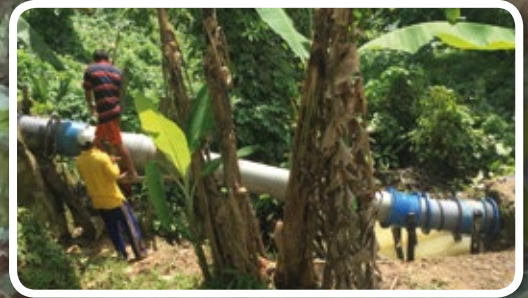
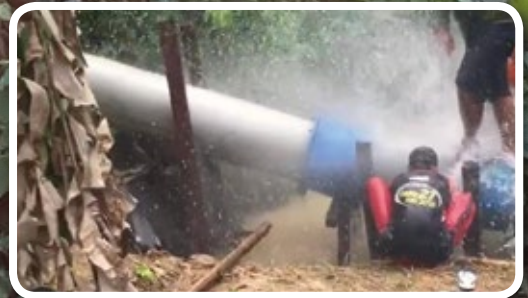
Problem - A 400 mm PE100 SDR 17 was leaking because customer had initially selected low grade compression fittings which were not able to grip the pipe. This pipe was taking raw water and transporting it to a local water treatment plant.

Solution - UltraGrip was installed to ensure a trouble free solution for a pipe that was leaking badly.
